Final Project Report – Lumina Caserones Mine Demonstration.

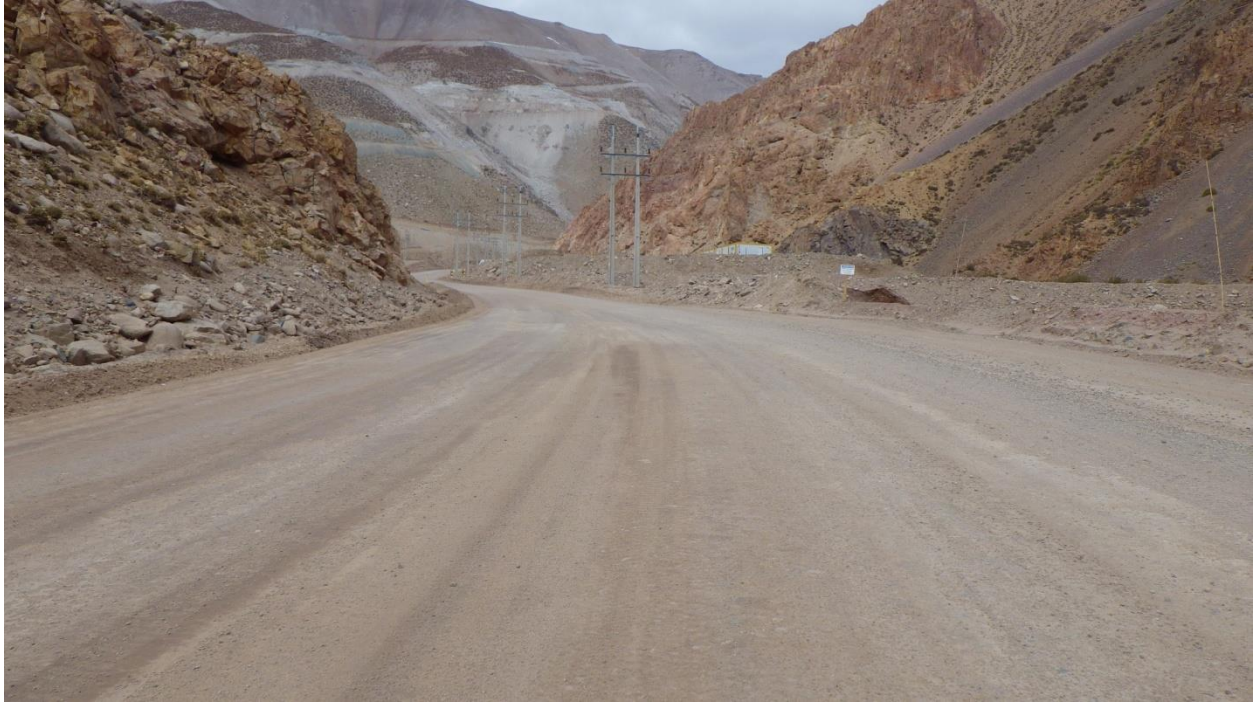
Trial road prior to application

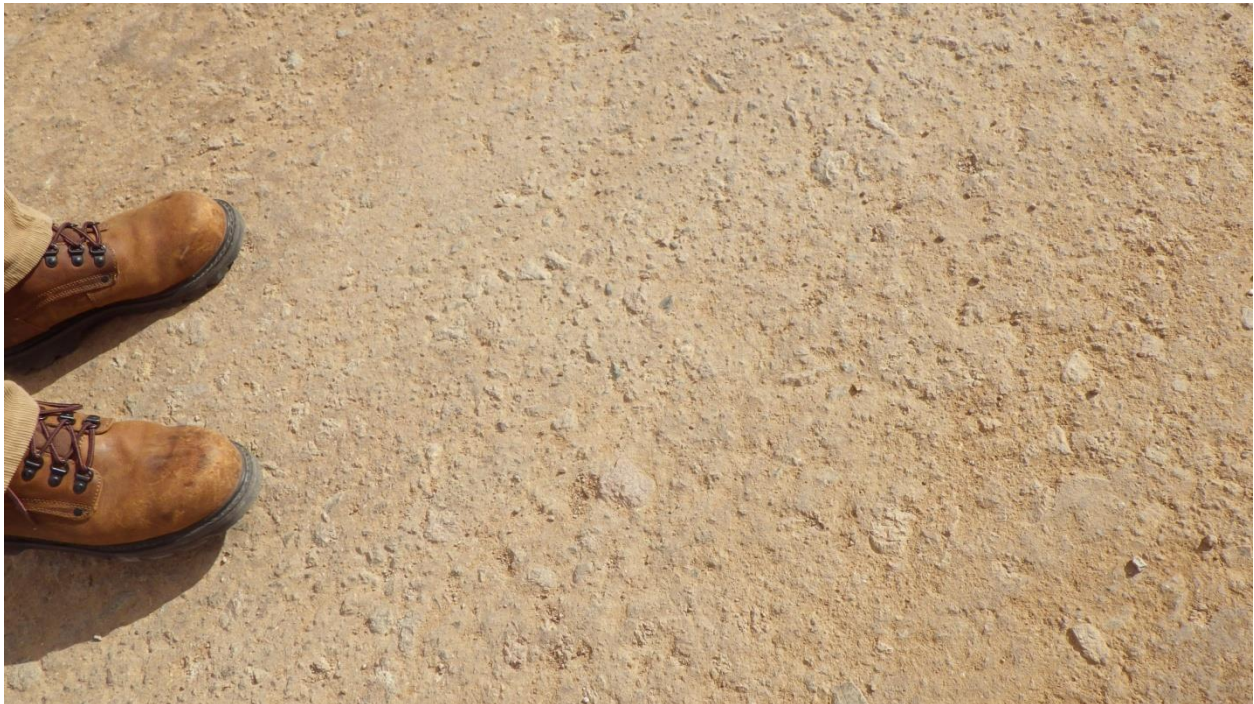
Example of the compacted surface of the road

- 1) Very hard road surface that minimized product penetration;
- 2) Sections of relatively steep gradients that caused some of the Earthbind solution to run down hill;

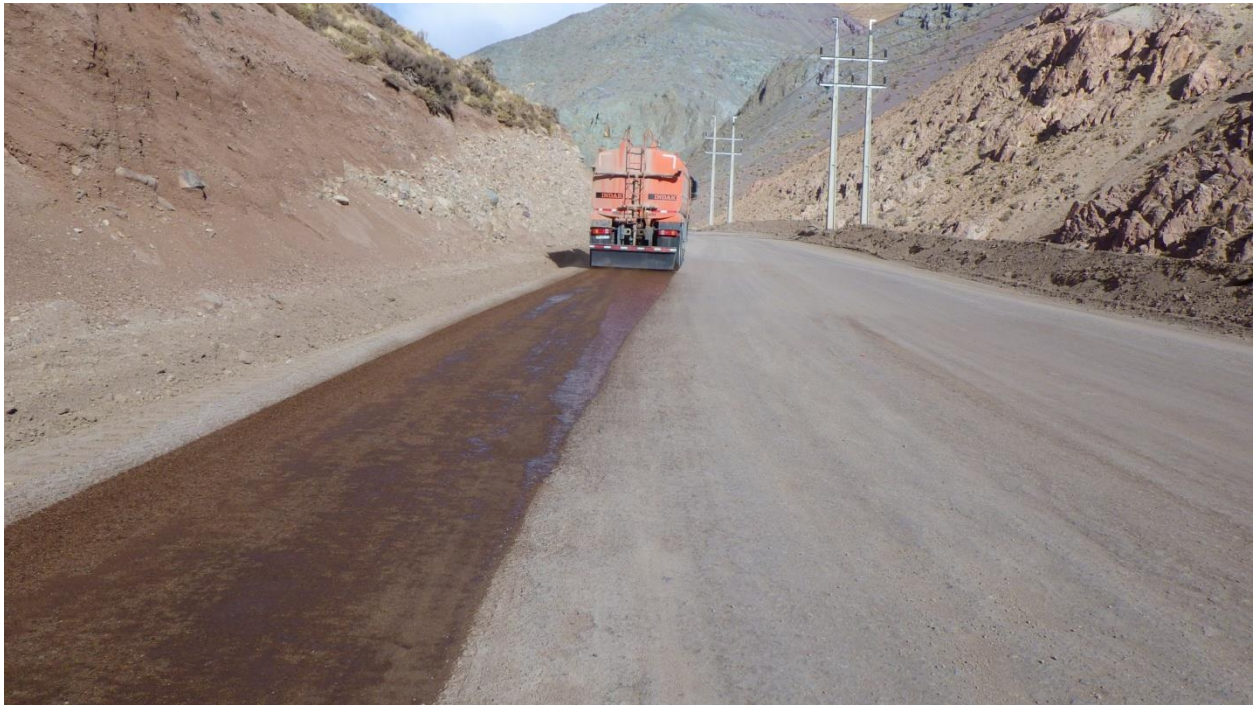
Example of the application rate that was chosen

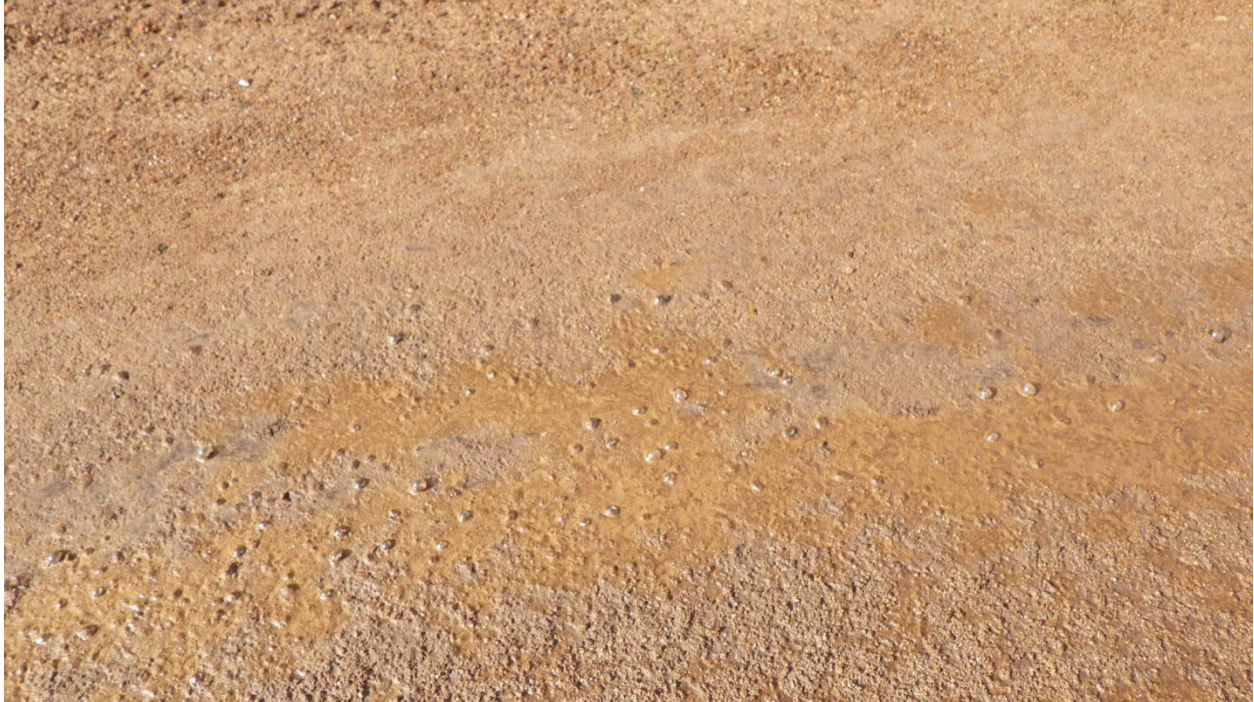
Example of how well the Earthbind 100 solution soaked into the compacted surface

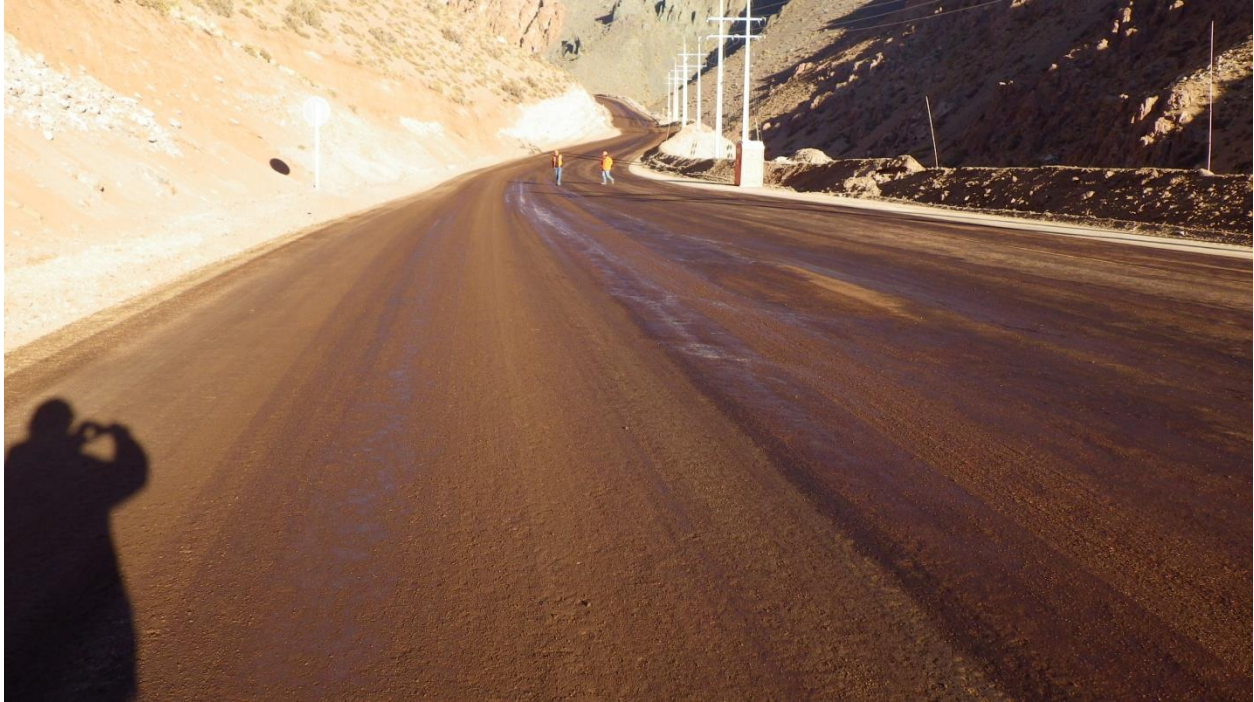
The application of the first tote (first segment), was done using a 10:1 solution (10 parts water to 1 part Earthbind concentrate) and applied at a speed of approximately 20 km/hour. This solution concentration was chosen due to the very hard surface and the high traffic. The application went well. The first tote of Earthbind was applied on July 23.

The road section after the first totes was applied (first segment)

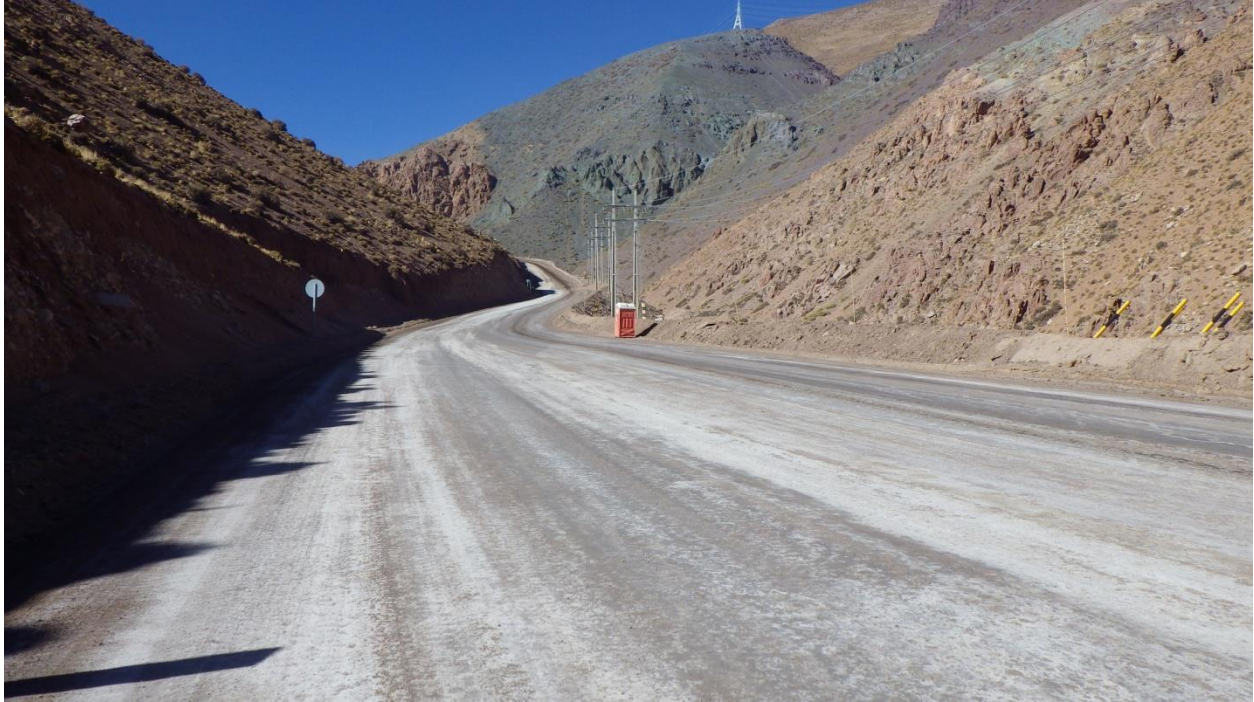
The second tote was applied on the morning of July 24. However, because of magnesium chloride crystals precipitating on top of the road surface due to the additional moisture used to apply a 12:1 solution, we decided to apply the second tote of Earthbind 100 using a 6:1 solution instead. The heavier concentration was chosen to minimize the amount of water applied to the road and to seal the surface to form a barrier so keep magnesium chloride crystals from migrating to the surface of the road as the Earthbind solution cures.

The trial road section covered with magnesium chloride crystals

- 9) Excessive magnesium chloride concentrations in the road material. We unexpectedly had a challenge with anhydrous magnesium chloride precipitating to the surface of the road due to the extra moisture that was applied using the initial 10:1 solution. Therefore as the Earthbind solution evaporated from the surface of the road, the magnesium chloride also “wicked” up to the surface of the road since magnesium chloride normally follows moisture. For example, as the Earthbind solution was drying on the surface of the road it also caused the magnesium chloride to be wicked up due to the evaporation process. In addition, freezing temperatures caused the hydrous magnesium chloride to turn into anhydrous magnesium chloride and precipitate on the surface of the road. This resulted in the road covered with a thin layer of dusty salt crystals. The precipitation occurred because the solubility of magnesium chloride decreases with colder temperatures. The high concentrations of magnesium chloride probably would not be an issue if the trial was done in warmer temperatures.

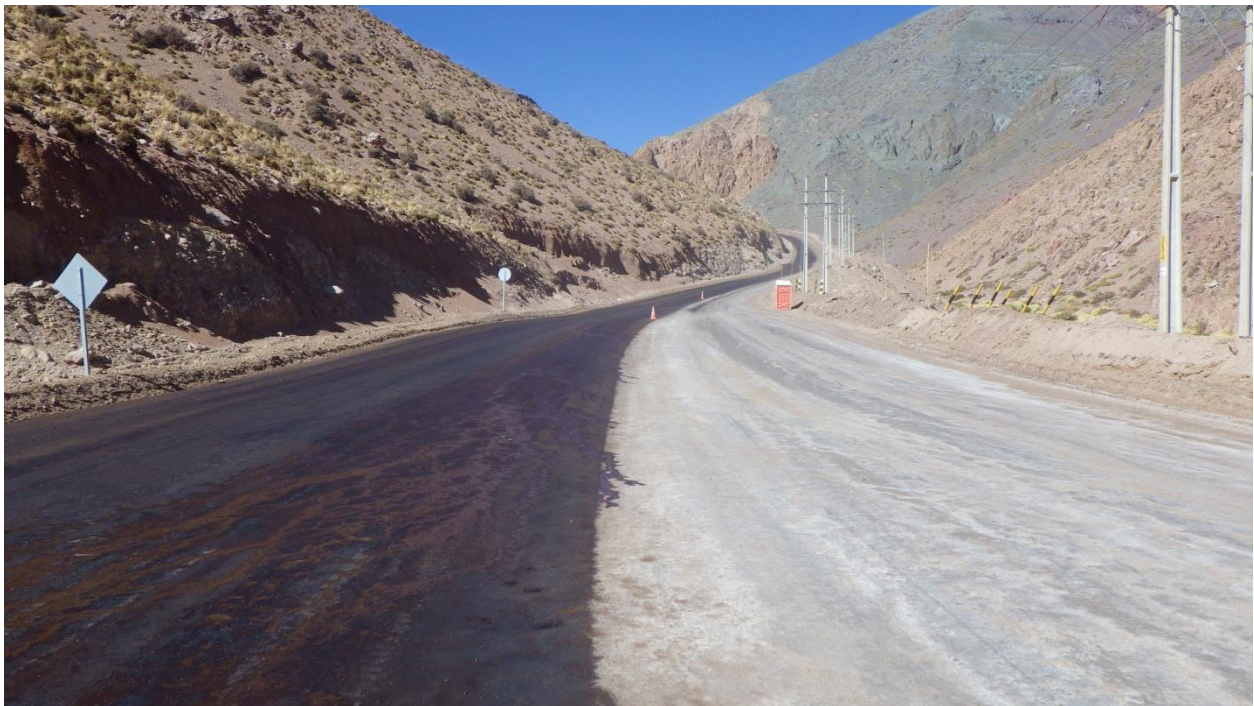
The left side of the road completed with the second tote of Earthbind. Note that the magnesium chloride crystals covered with the Earthbind solution.

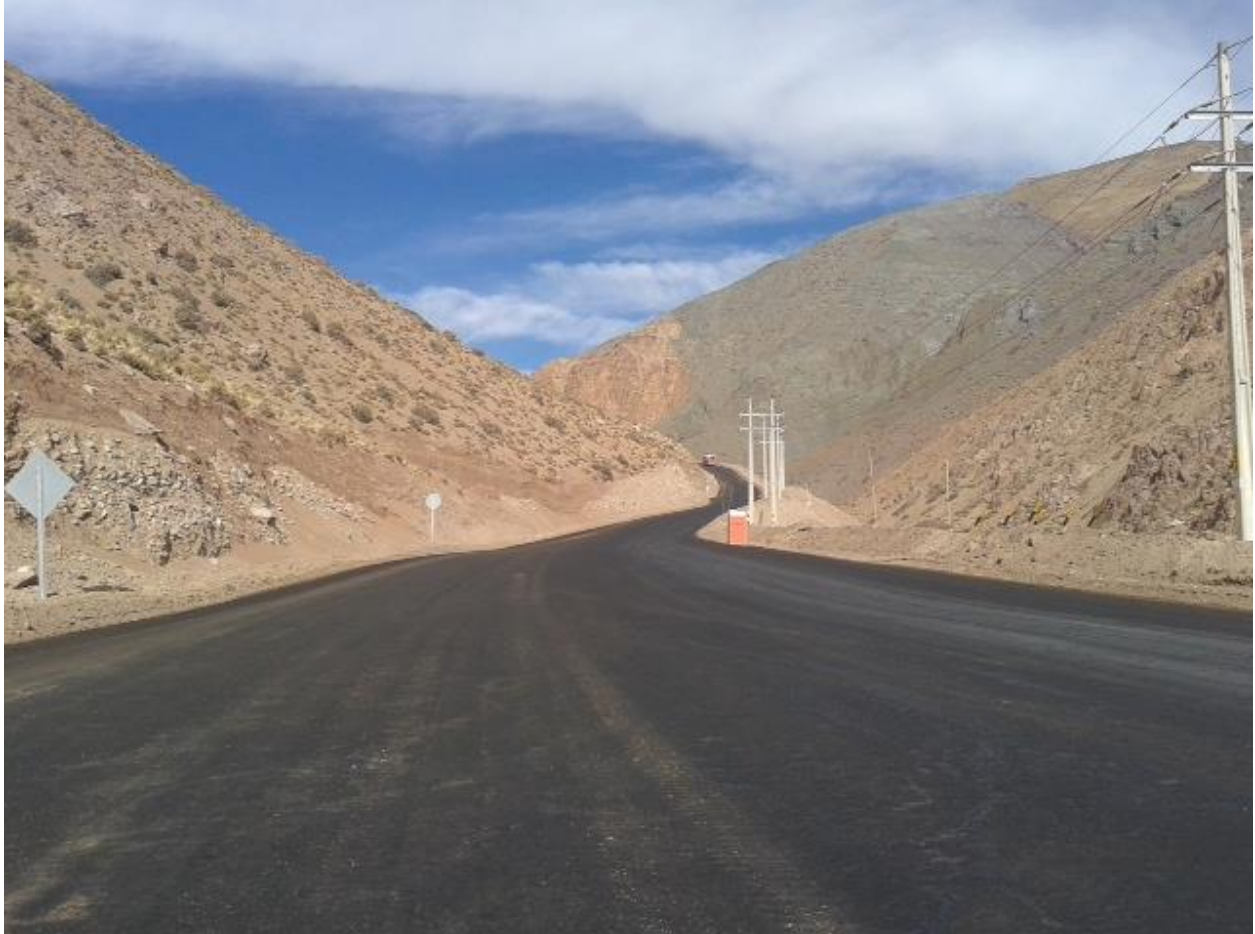
The trial road section completed.
